## Mt Pleasant parking lot

August 29, 2015

Walk, field measure, observe, document, and recommend action, for Parking lot bordered by hwy 271 1<sup>st</sup> Street w Alabama and Van Buran in Mount Pleasant Texas See enclosed photo.

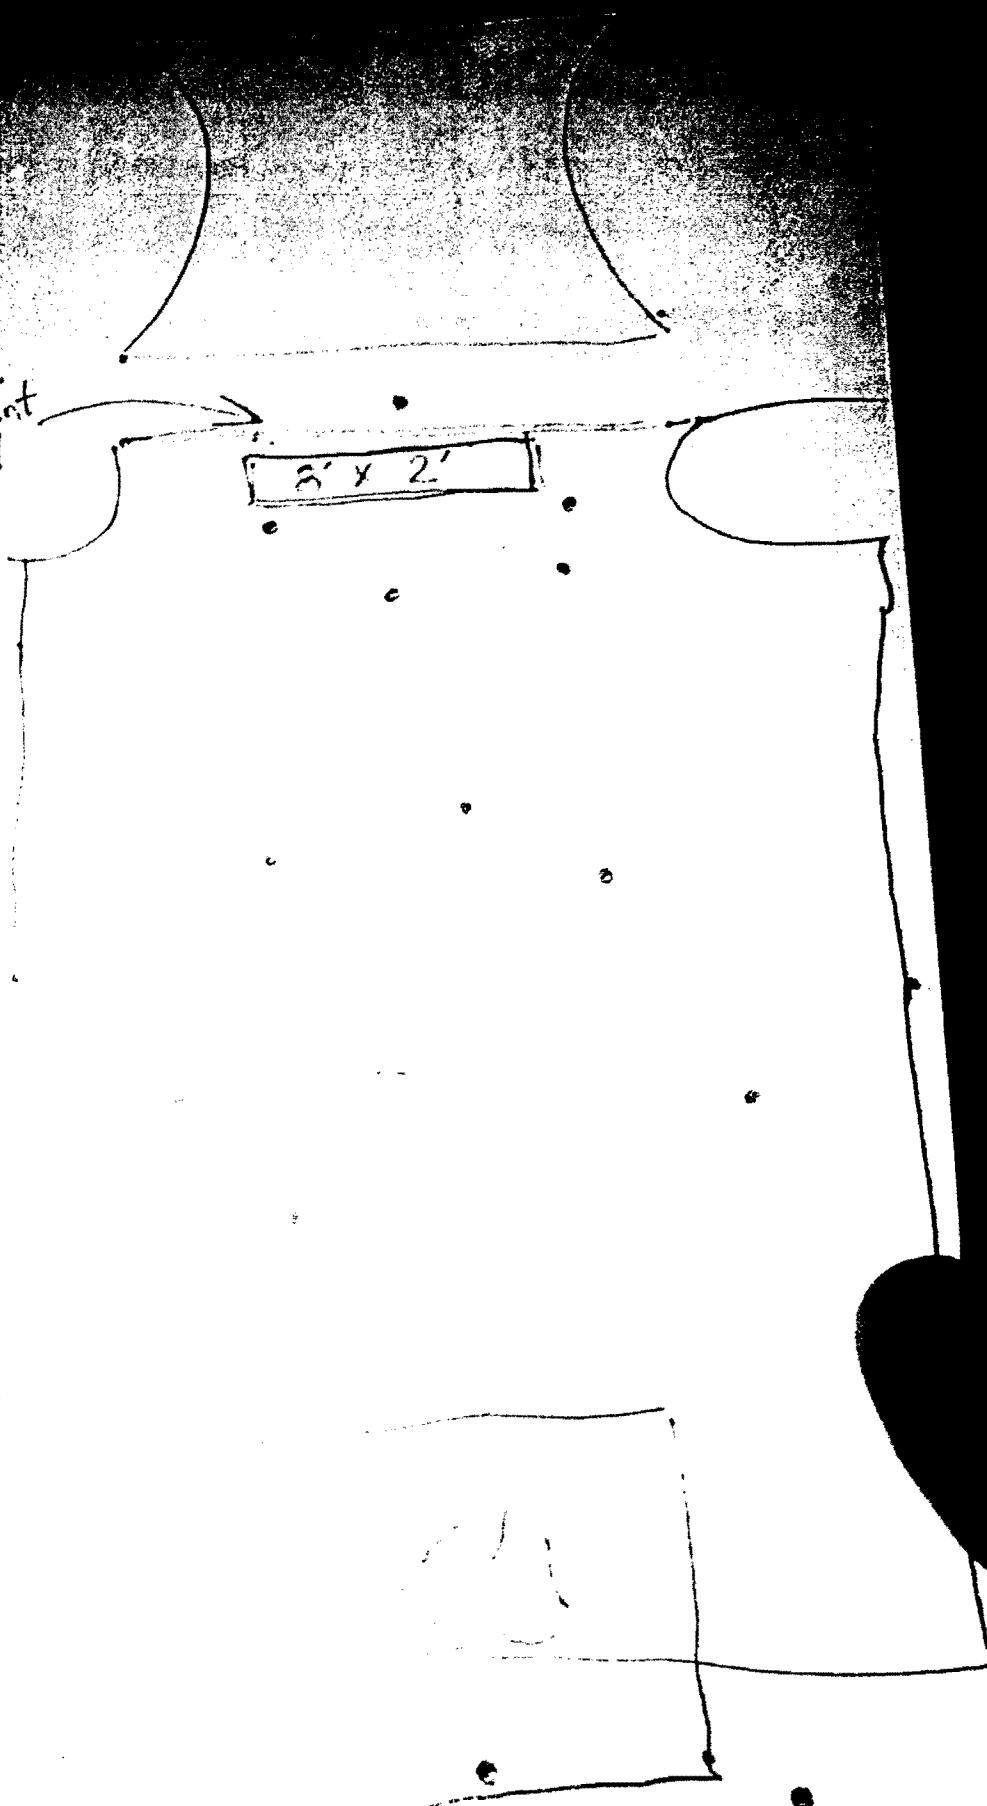
Pg 1

To follow up on your question regarding the size of the areas with sub grade separation. two areas of concern are located at the south most approach at the degraded expansion joint. This is an area aproxamantly 2 feet either side of the expansion joint and eight to fifteen feet wide. This area showed as much as 4 to 6 inches of separation and to the north up to within ten to twelve ft north of the hole that is coned off. This area is about ten by ten either side of the hole at 5 to 6 inches and extending out further to twenty feet 2 to 3 inches down to 1 inch at 25 ft. The first area would have 60 to 80 sf of severe separation and another sixty to eighty ft of minor separation. The second area has 150 to 200 sf of severe separation and another 100 sf of minor separation. The flowable fill material is designed to extend beyond the areas cut out and close the separation between sub grade and the underside of the paving. A stinger vibrator and flowable fill at 7 to 9 inch slump should allow the material to flow to 25 to 30 ft. Brian let me know if you need me to do anything else.

Exp Joint  
#1

8' x 2'

3. An area located at southern most approach 8ft X 2ft should be removed and replaced with 3000 psi concrete doweled with #3 rebar drilled 6-8 inches into existing concrete and 12 inch minimum left into new concrete, these should be placed on 12 inch centers.

4. In addition an area 10ft X 10ft minimum around existing failed area should be removed and replaced utilizing the same procedure as above. This area should also include #3 rebar on 12 inch centers each way. Note this area should be increased according to subgrade separation observed at the perimeter. A mix designed with reduced large aggregate and increased sand should be placed at a high slump and allowed to flow under and replace void in additional areas adjacent to the removed concrete to be replaced. This procedure should be used for both areas to be replaced and a surface vibrator or sting vibrator, should be used to increase the flow potential of the concrete used to replace any voids beyond that of the area removed. Follow with replacement concrete mix design for pavement replacement and do not use any material other than the two mix designs. No sand shall be used to decrease depth of paving.
