MOUNT PLEASANT, TEXAS

TITUS COUNTY ANNEX OBSERVATION REPORT

PREPARED BY PRIEFERT COMPLEX DESIGNS

RE: Building Assessment of the Annex Building, Mount Pleasant, TX

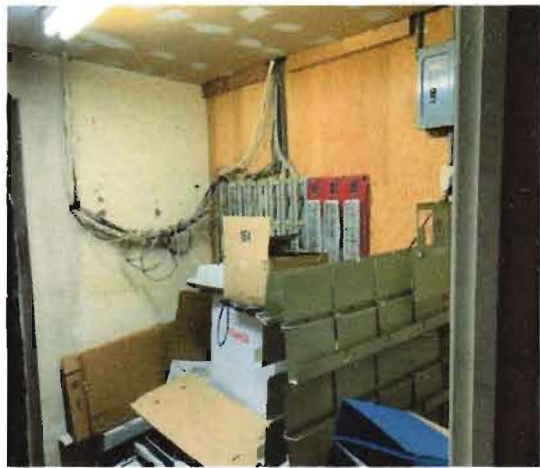
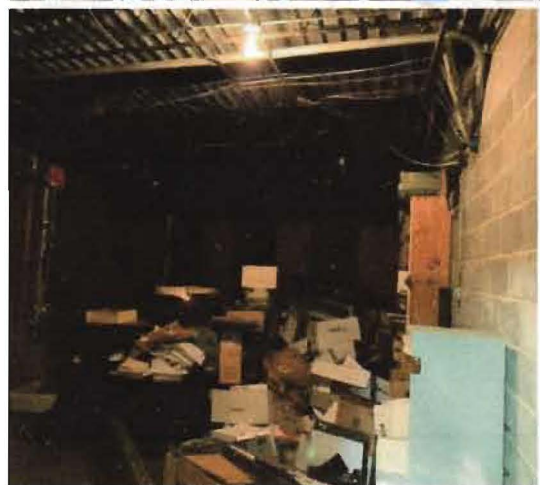
Special consideration should be given to allocating space designed specifically for storage. It does not appear that storage was the original intended use for the rooms now being used for that purpose. Rooms on the second floor of the building contain massive amounts of material including documents, office supplies, and miscellaneous stacked items. If these spaces are to continue to be used for storage, it’s important, due to the combustible nature of the items being stored, that a fire suppression system be installed. The National Fire Protection Association (NFPA) specifically addresses the use of storage and housekeeping in mechanical and electrical rooms.

Structural systems also require special loading considerations to provide adequate support for storage areas. The adequacy of the structure is suspect in these storage areas, but no structural analysis was performed.

Specific Storage Designations

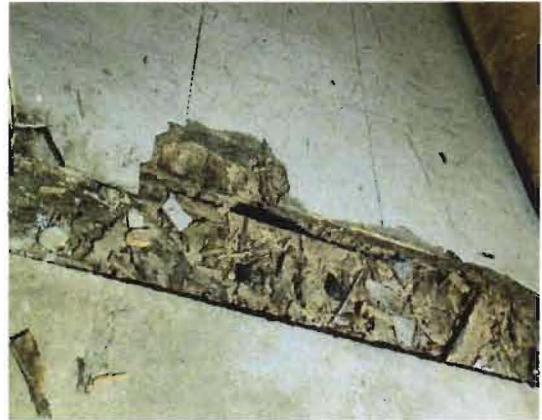
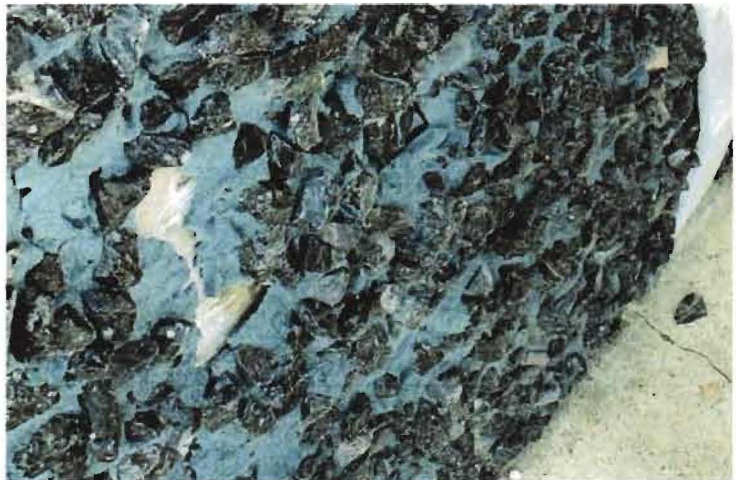
Asbestos, commonly found in ceilings, insulation, concrete and ductwork, can be a hazard when disturbed. Prior to demolition, it is important that testing be performed if older building products are present. During the inspection, we noticed a few areas where the possible existence of asbestos was a concern. To address this, testing was performed on June 13, 2019 by Brady Environmental Services.

Brady took a total of 20 samples at various locations. Two “hot” areas were found that will have to be removed if the project proceeds. Typically, this is not a significant concern or cost, but must be remediated and disposed of by a qualified company.

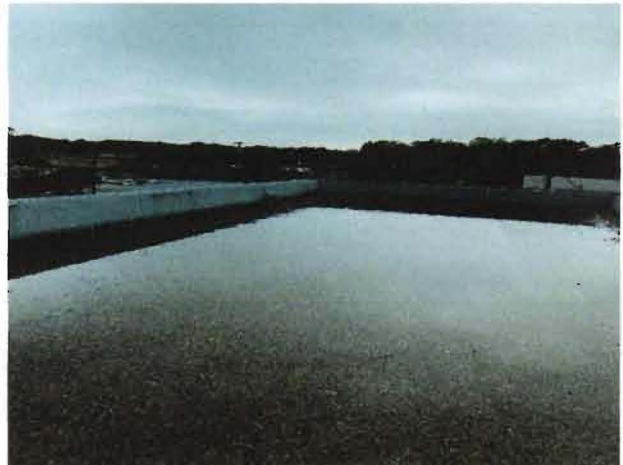
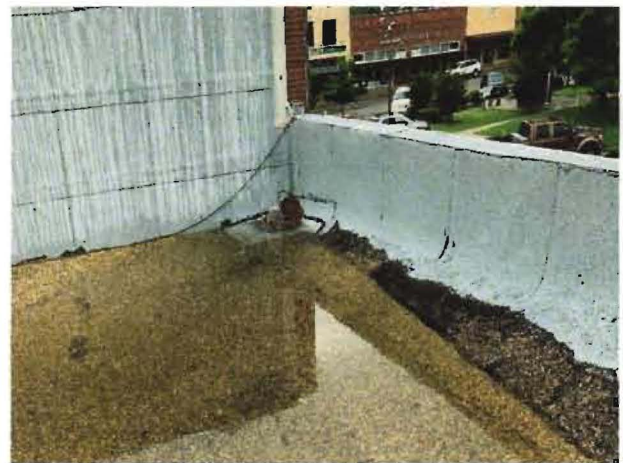
On the day of the site visit, the roof of the building was thoroughly inspected. It was observed that drainage, due to rainfall, was unable to escape the rooftop and properly drain in a timely manner. There are both roof structure and code requirement concerns. The NRCA, National Roofing Contractors Association, recommends that, “all roofs be designed and built to have positive drainage. NRCA defines positive drainage as the condition in which consideration has been made, during the design, for all loading deflections of a deck, and also that additional roof slope has been provided to ensure drainage of a roof area within 48 hours following rainfall under conditions conducive to drying.”

Water was unable to escape roof drains due to debris clogging drains on the flat roof. The absence of overflow scuppers further limits the drainage and could lead to potentially dangerous ponding problems. Ponding on the roof could be damaging to the building if the roof structure is not designed to carry the additional water loading.

It should also be pointed out that freezing temperatures in the winter months can cause additional issues. Water standing on the flat roof will have the potential to freeze and, in the event of a snow storm, this frozen layer can accumulate snow drifts exceeding the building's structural capacity.

Regular maintenance inspections of the roof should be scheduled (based upon the comments above) to ensure that drains are free and clear of debris, and that water is not collecting on the roof over an extensive amount of time. Overflow scuppers should be installed through the building parapets to alleviate ponding in the event the roof drains get clogged.

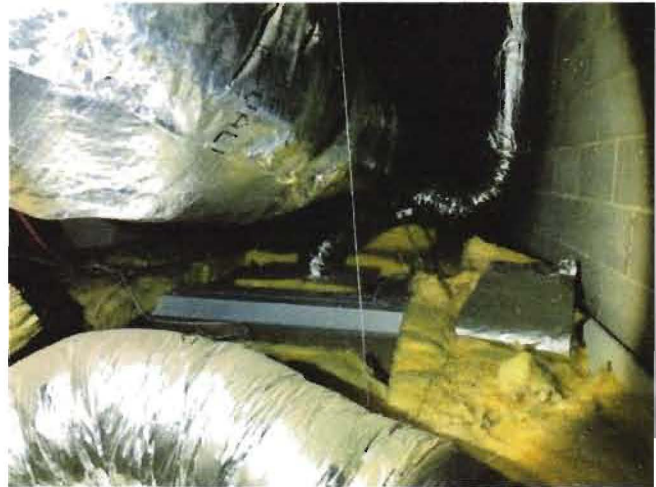
The IBC defines buildings of Type III construction as buildings with exterior walls that are noncombustible and interior walls constructed of any material. The roof structure and much of the interior framing of the Annex Building is of wood construction, a combustible material, while much of the interior load-bearing structure was constructed of non-combustible load-bearing masonry*. IBC's Table 506.2 limits the square footage of this construction type to 9,500 square feet, if a sprinkler system is not provided. The total area of the Annex Building, including the area for the new courtroom totals approximately 10,000 square feet.

Annex walls constructed many years ago, originally provided proper protection of one space from another. But over the years building modifications have resulted in large openings being made, thus compromising the firewalls. In many cases, these large openings in the masonry are supported by structural steel beams. Beams used in this manner would require fireproofing to delay collapse during a fire. No fireproofing was present.

Because the building areas are no longer protected by fire-rated walls, a sprinkler system is required for the building by IBC and NFPA. There was no fire suppression system observed in any of the building. Additionally, a sprinkler system should be installed to serve spaces above and below the ceiling due to the presence of combustible material in the spaces.

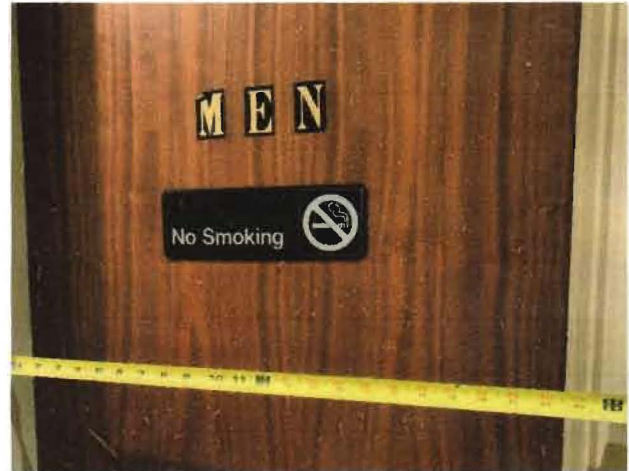
During initial inspection the quantity of restrooms serving the major court room and front office staff appeared sufficient. IBC has specific requirements for Water Closet and lavatory quantities. For this building use, the quantity of water closets must meet the following: 1 per 125 for males and 1 per 65 for females. These restrooms also appear to be in general compliance with ADA guidelines. Some adjustment to them will be required to obtain full compliance.

Restrooms in the lobby area are suitable, but those in the back portion of the building, serving Court Room B, are not. Openings into these restrooms measured 22 inches; current code standards require that openings be a minimum of 32 inches. In addition, fixtures should be modified to adapt to ADA requirements. After analyzing the existing flaws in these restrooms (and considering that their intended purpose is to serve a courtroom) it may be desirable to remodel them in full. Initial plumbing rough-in could be salvaged so that foundations do not have to be torn out.

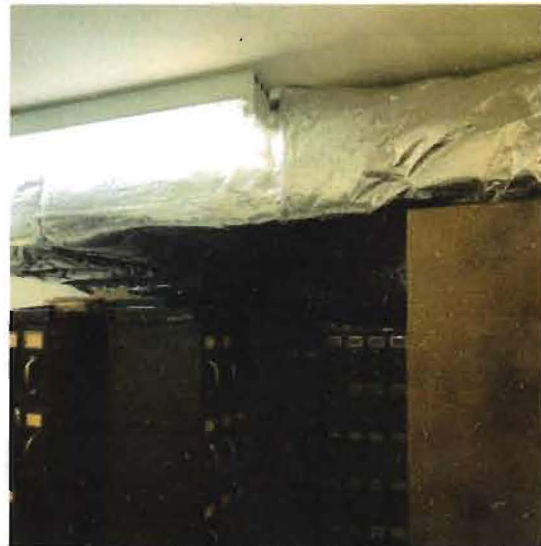
On the roof of the building it was observed that most of the units serving the building were installed within the last ten years. However, when observing the space above drop ceilings, it was apparent that numerous modifications to the duct work have been made over time. The maze of ductwork has likely reduced the efficiency and air flow of the system. If renovation is undertaken, the HVAC system should be investigated by a professional mechanical engineer to ensure good performance and efficient operation.

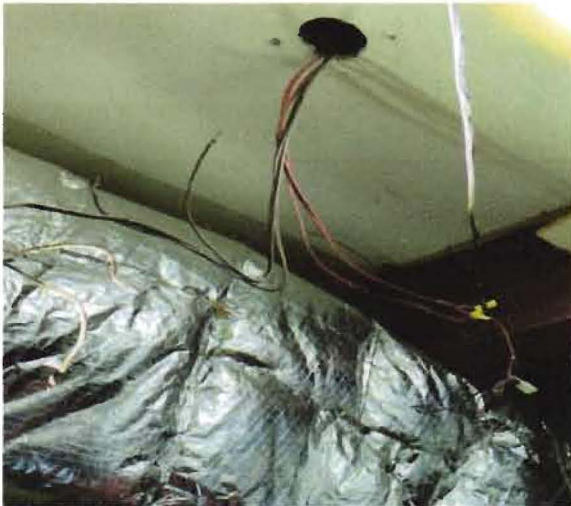
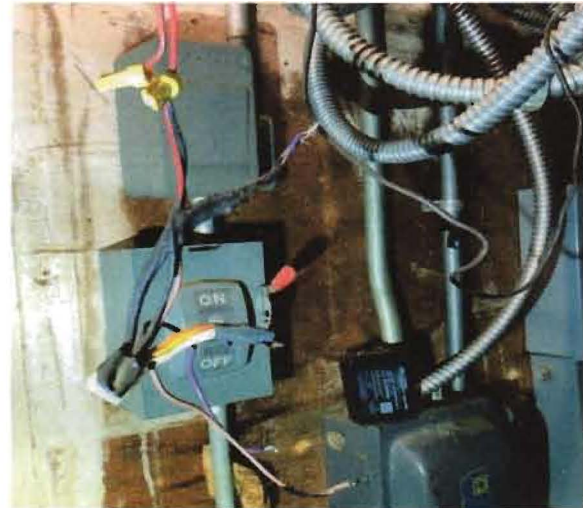
Electrical wiring was observed in multiple rooms. The wiring was installed in an unworkmanlike and potentially unsafe and non-compliant manner. Out-of-service wires were not put away in a secure manner, leaving some that were exposed and live. This could potentially lead to fire hazards or injuries to personnel. In this instance a certified electrician should be contacted to thoroughly inspect and address the areas of concern and bring these areas into compliance with the National Electric Code (NEC) and the acceptable standards of workmanship.

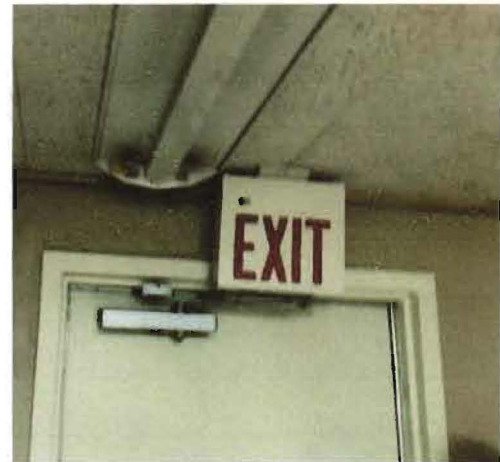
Per Table 1017.2 for occupancy Type A (Assembly), exit access travel distance is limited to 200 feet. During the visit it was noted that, in some places, the path of egress was unclear, due in part to issues with emergency exit signs. It was noticed that not all exit signs were working properly.

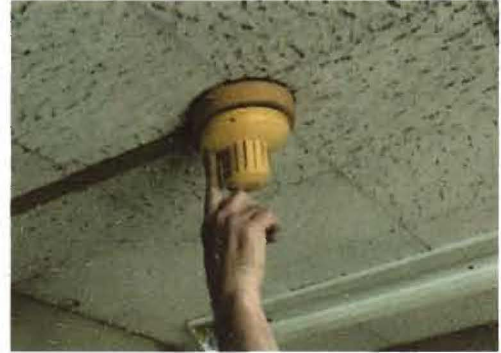
A manual fire alarm system that activates the occupant notification system in accordance with Section 907.5 shall be installed in Group A occupancies where the occupancy load is greater than 300. Manual fire alarms were present in the building, however they appeared to be outdated with no signs of being operational. Smoke detectors installed in the ductwork were observed but were not tested to determine if the system was functioning properly.

Keeping the fire alarm system in service can be a challenge. However, simple and periodic inspections performed by a Fire Protection company would help ensure a working system.

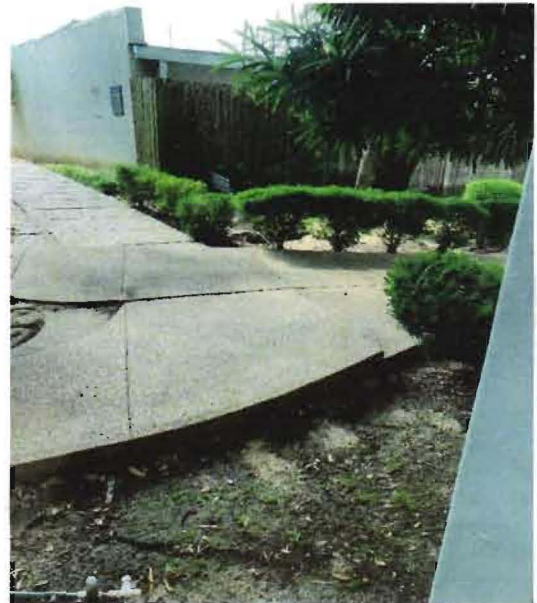
Access to the building is non-compliant and hazardous. Over time, the walkways have settled and heaved due to improperly constructed concrete joints, tree roots and erosion.

Currently, the building does not comply with the standards set by IBC and the ADA regarding parking or access by the disabled. Among the required standards are:

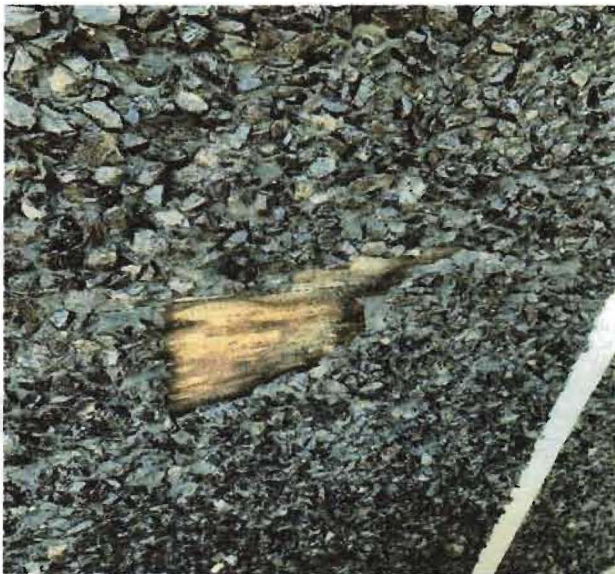
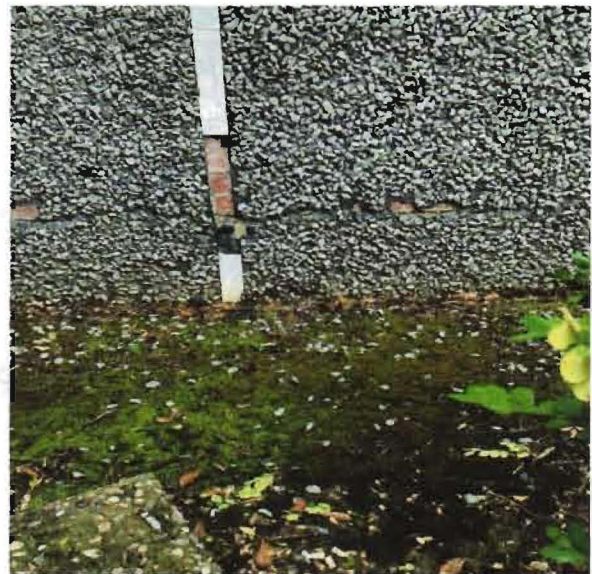
**It should be noted that parts of the building do not comply with the requirements of Type III construction. Wood was observed at areas on the north façade where finishes had deteriorated. This combustible material further emphasizes the deficiencies in the fire protection system and places importance on the need to address this issue.*

Deterioration of the façade was noted around the perimeter of the building. Serious weathering has occurred on the north exterior façade of the building. The aggregate covering has separated, and in some cases fallen off the wood substrate. Having wood exposed to exterior elements such as moisture could lead to mold growth, rotting of the exterior sheathing, reduced insulation value and rapid overall façade deterioration.
