This document is a "Review of Subdivision Plans", as required in Title 30, Texas Administrative Code, Chapter 285 – Onsite Sewage Facilities, and more specifically: §TAC 285.4(c) "Review of Subdivision or Development Plans"

Proposed Development/Subdivision Site: LostPinesTX LLC "Lost Pines" Subdivision, Titus County, Texas

Subdivision/Development Review for On-Site Sewage Facilities

Lost Pines (LostPinesTX LLC) at Lake Bob Sandlin, Titus County, Texas

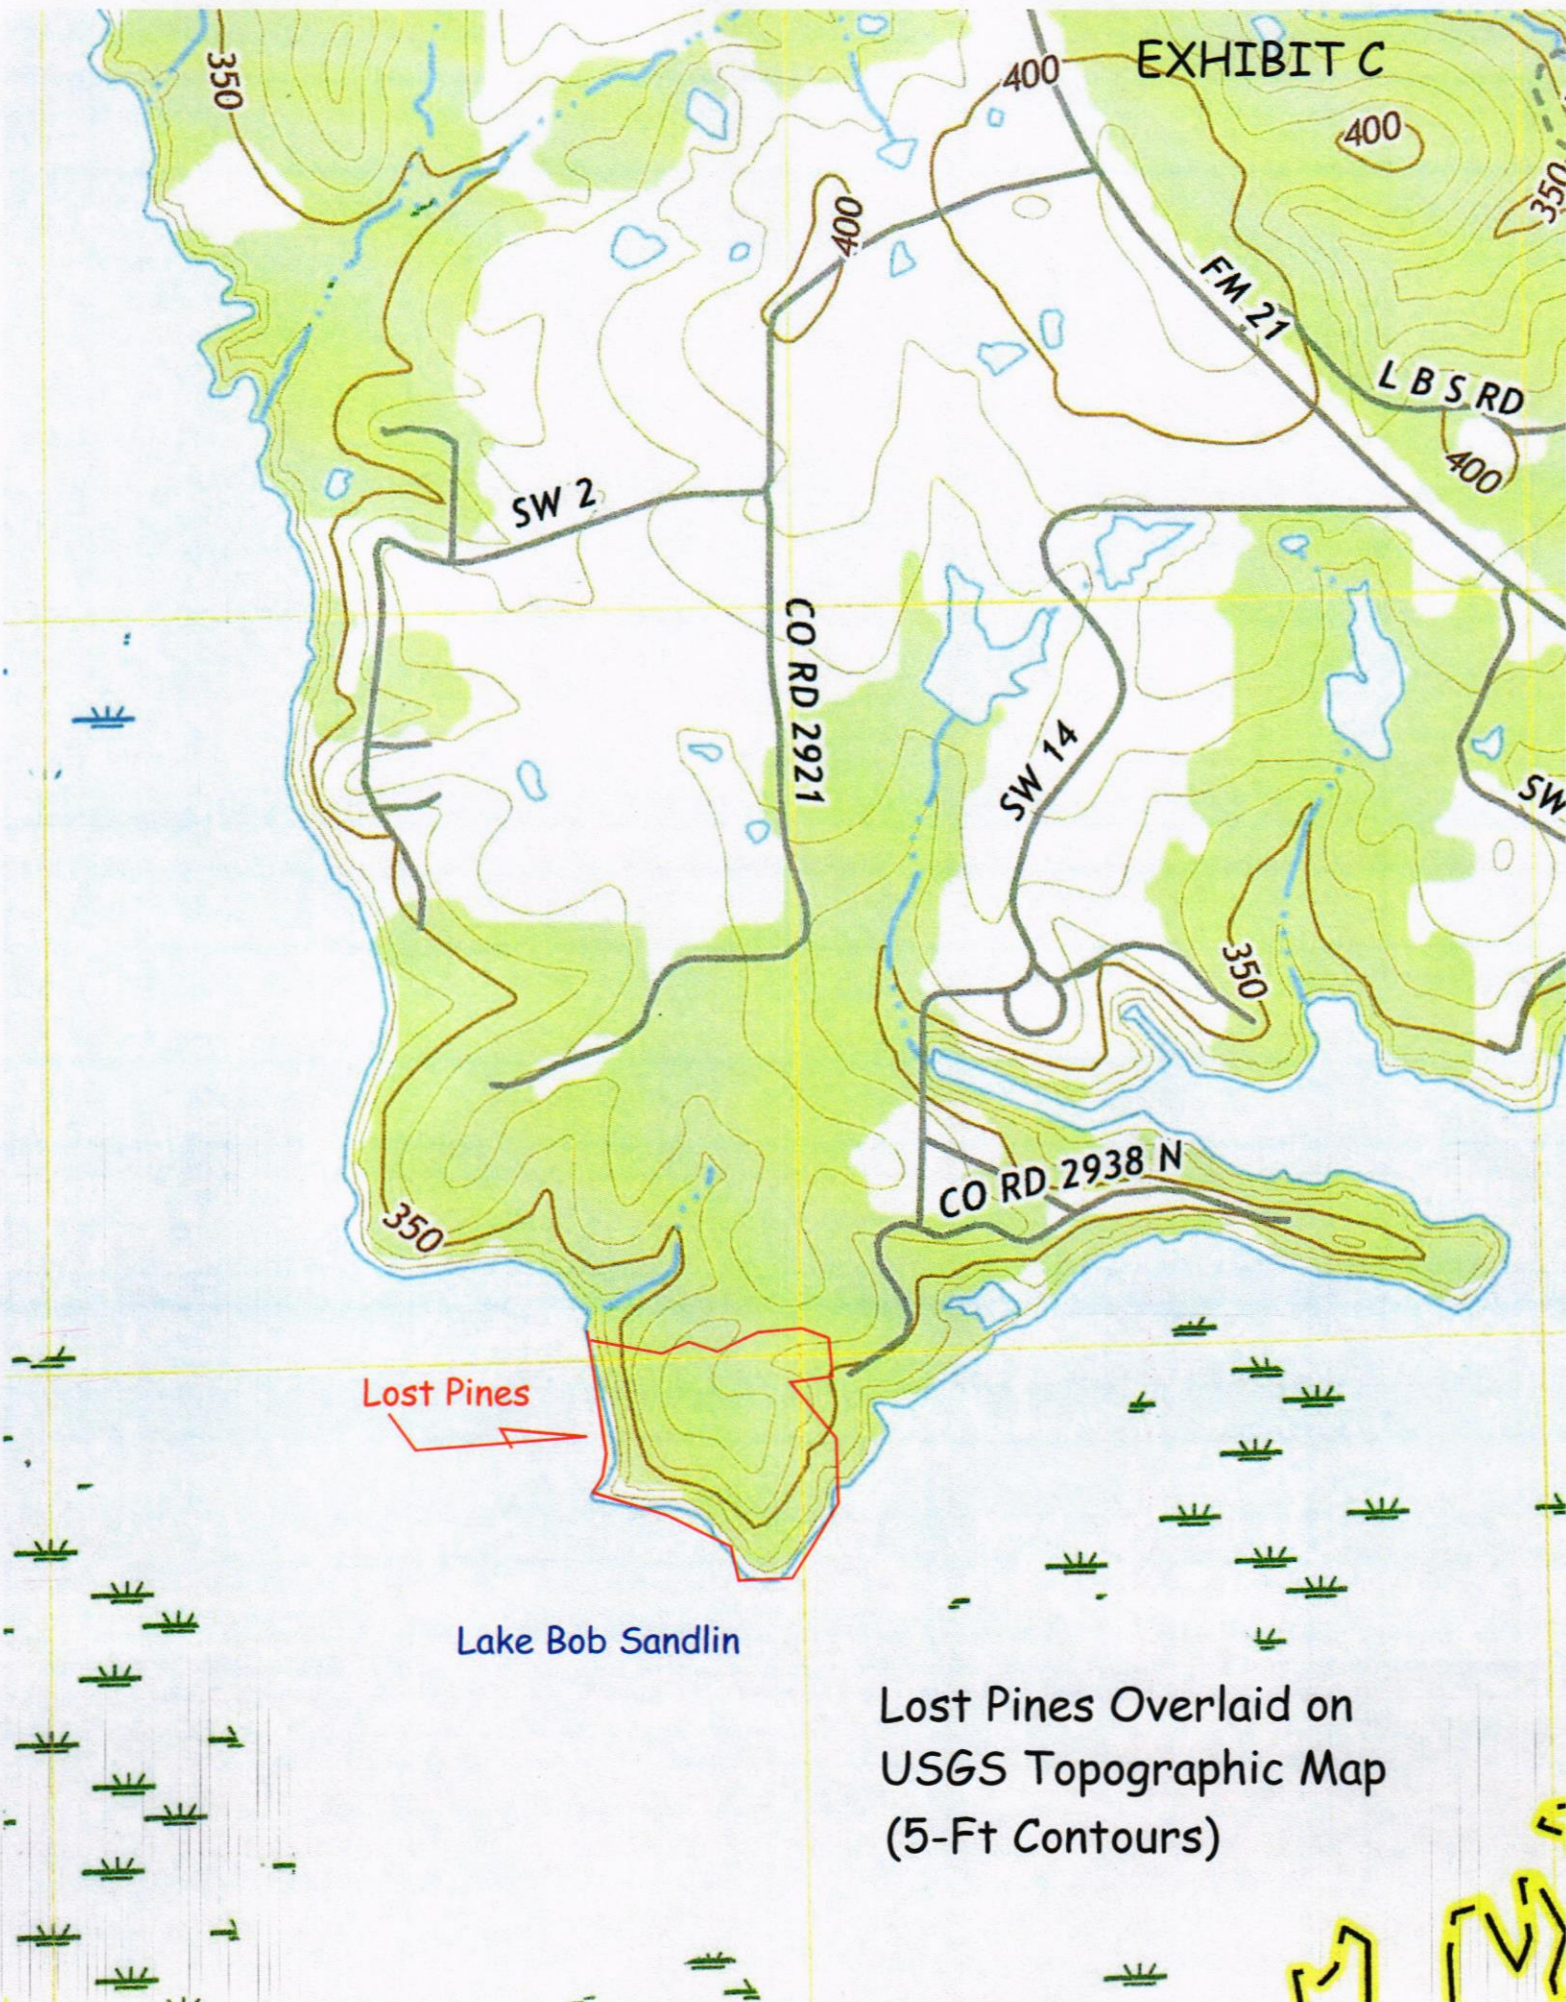
Lost Pines Overlaid on
USGS Topographic Map
(5-Ft Contours)

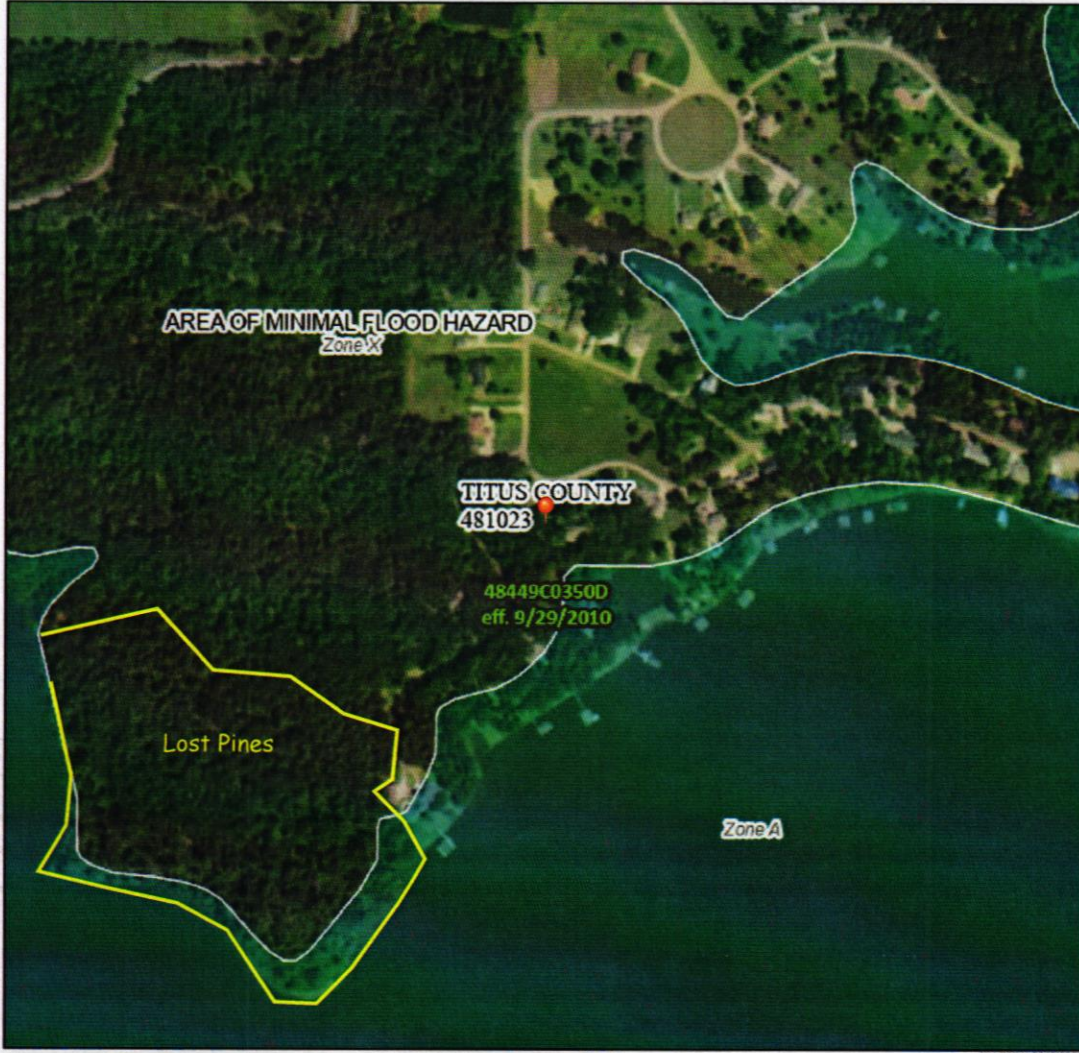
EXHIBIT E

National Flood Hazard Layer FIRMette

Note on Exhibit E – This area of Titus County has been recently been “mapped” by FEMA and as such, FEMA Flood Zone Maps are available, but do not now show the area prior to inundation by Lake Bob Sandlin. Please be aware of the 342’ MSL contour and the line marked as “flowage easement” by Titus County Fresh Water District No. 1 are at different elevations.. The 342” MSL is the emergency overflow level of the Fort Sherman Dam. As Lake Bob Sandlin was being constructed (1974), an engineering firm established this “flowage easement: line as the demarcation below which inundation may occur under flood conditions. By TCFWD rule, Section IV(A)(4) reads as follows: “No septic tanks or other facilities or uses which might bring about pollution of the reservoir shall be permitted within the confines of the easement.”
